Three-dimensional Modelling of the Interaction Between Buildings and Tunnelling Operations

Conference theme: Effects of building stiffness, different configurations and time

3. Ramsgate Harbour Approach Tunnel Case History

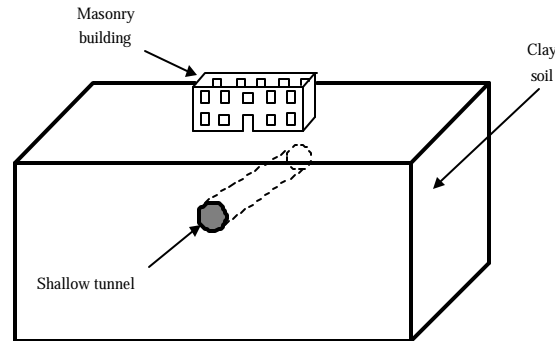
Figure 1: Idealisation of tunnelling under a building in three dimensions

The facades of the structure are modelled by plane stress elements. The roof, floors and internal partitions are not included, although internal load-bearing structural walls are included when necessary. The facades are connected together and to the ground using tie elements (Liu, 1997; Houlsby *et al*, 2000). Foundation details may be modelled if necessary, but are often neglected if the building is on strip footings.

Ten-noded tetrahedral solid elements model the ground, with a free mesh that enables the density to be increased near the tunnel and building. The ground contains a zone of elements defining the tunnel, and these are removed during the analysis to simulate excavation. This may be carried out incrementally to model the response as tunnel construction progresses: this cannot be done in two-dimensional analysis. The tunnel may be unlined, or lined with shell elements, which enable the ground loss due to tunnelling to be controlled and modelled.

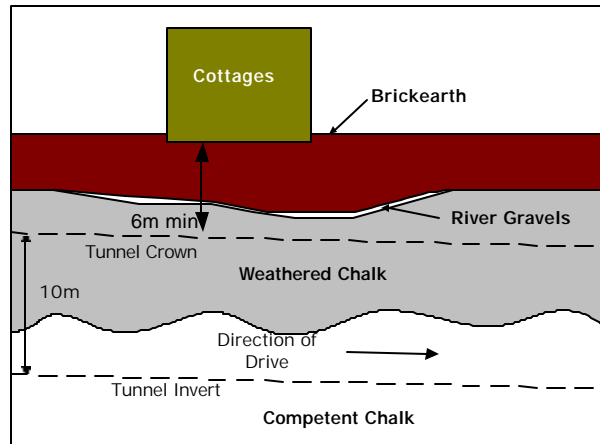
Figure 2: Section through cottages on axis of tunnel

however, the Chalk is weathered to grade Dm in places and the thickness of the overlying surface layers become significant (Fig. 2). The tunnel invert remains within chalk that is structured and relatively unweathered, but still rather weak. The upper part of the bore is in weathered to highly weathered chalk. Overlying this is a layer of 2m - 3m of red brickearth, a firm to stiff silty clay. At the location of the cottages, a buried valley crosses the alignment, decreasing the chalk cover over the crown, and increasing the penetration of weathering.

observed settlements in Figure 10. Agreement is good, particularly at the rear. The model over-predicts the settlements at the front, which were less than at the rear probably because of the less depth of brickearth at the front (Fig. 2).

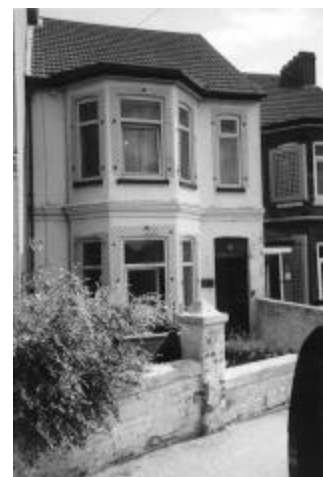
The cottages consist of a terrace of eight similar properties, dating from the early 1900's (Fig. 3). The tunnel passes under the cottages with about 6m cover, on a skew, with the angle between the tunnel axis and front of the cottages being 40° (Fig. 4). The houses are of two storeys, 6m high and without basements. They are of load-bearing brick, on shallow strip foundations, with wooden suspended floors and ceilings. The most important load-bearing walls for each cottage are the party walls each side and the front

Figure 3: Typical cottage

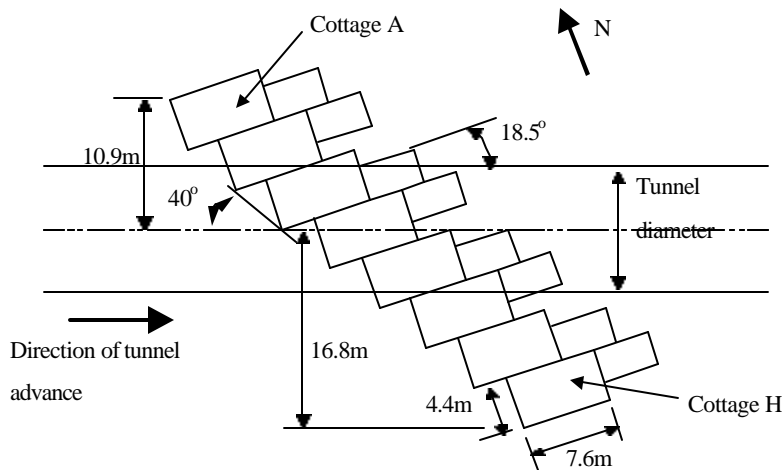
Figure 4: Plan layout on tunnel and cottages

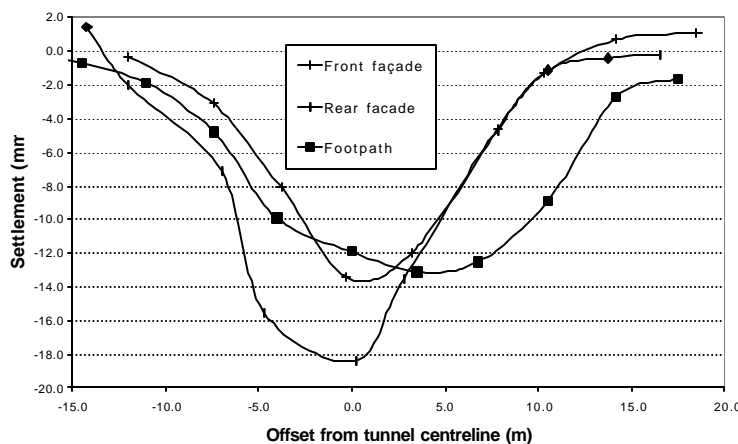
Figure 5: Observed settlement profiles

from the cottages and a section on the footpath in front of them. The settlements finally stabilised after two weeks, although the majority of settlement occurred in the first four days after the tunnel face passed. The maximum settlements observed were 13.4mm at the front, 18.4mm at the rear and 12.8mm on the footpath (Fig. 5).

The final settlement troughs approximated reasonably well to Gaussian shapes, with a trough width parameter (i) estimated as 4.5m at the front, and a calculated volume loss of 0.15% - 0.20%.

When the building was included in the model, the surface settlements were as shown in Figure 9. They did not differ significantly from the greenfield case, indicating that in the model the building responded flexibly, as observed in the field (Fig. 5). Profiles of the façade settlements predicted by the model are compared with the

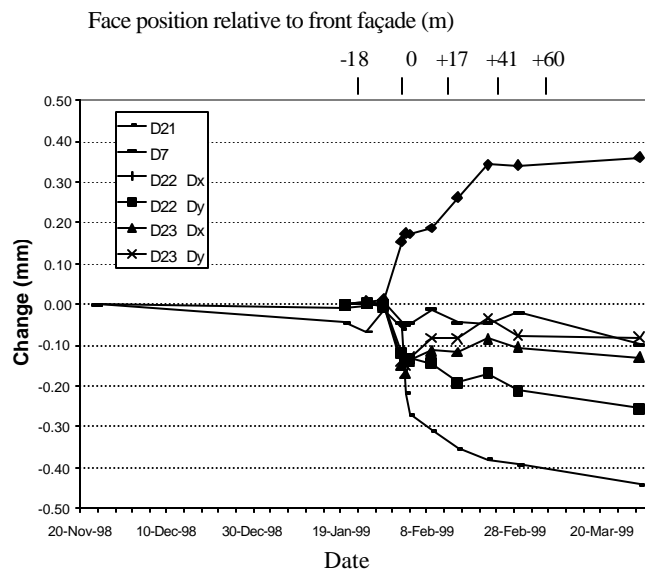
Figure 6: Movement of pre-existing cracks

The Demec studs on the front of the cottages within the settlement trough recorded some slight movements (Fig. 6). Some cracks were observed to open, some to close, and some did not move significantly. The magnitudes of the typical movements, at 0.4mm – 0.5mm, represent a damage category of Very Slight in the Burland *et al* (1977) classification. The readings at the rear were similar. The damaged cottage at the southern end was outside the observed settlement trough, and although movements of cracks of up to 2mm were observed over the duration of the project, they were not strongly correlated in time with the passage of the tunnel heading.

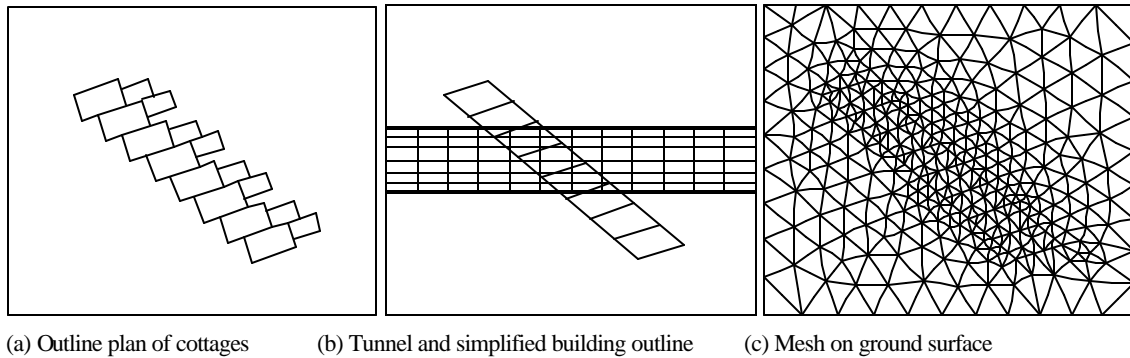
The development of the geometry of the facades of the terrace was simplified as shown in Figures 7(a) and (b), with the front and rear facades modelled as straight and the party walls between cottages included in the model. The tunnel passes beneath the terrace as shown in Figure 7(b). The finite element mesh for the ground is shown in Figure 7(c) and Figure 8.

Figure 7: Development stages for the finite element model

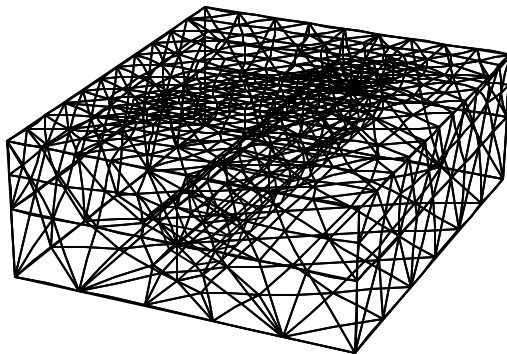
Figure 8: Finite element mesh for ground

The ground above the axis of the tunnel, weathered chalk and brickearth, was modelled with the multi-surface plasticity model with an undrained strength profile with depth z in metres below ground level $s_u = 60 + 28z$ (kPa) and a ratio G/s_u of 1500. The competent chalk below axis level was modelled as an elastic material. The mesh density in the ground beneath the building was increased until the greenfield settlement pattern was no longer sensitive to it. The complete model of the ground and building combined contained about 8000 elements and 30,000 degrees of freedom.

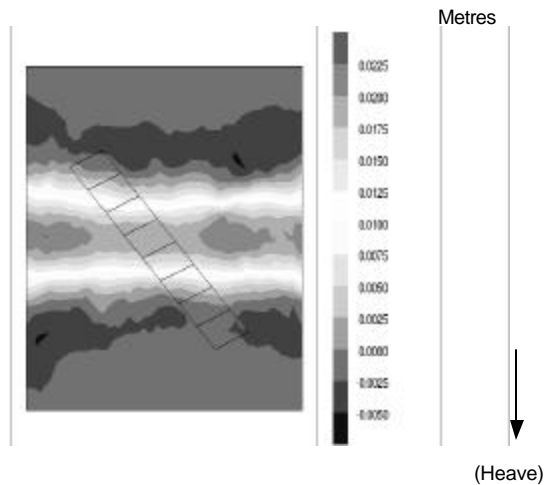
Figure 9: Surface settlements from fully-coupled model

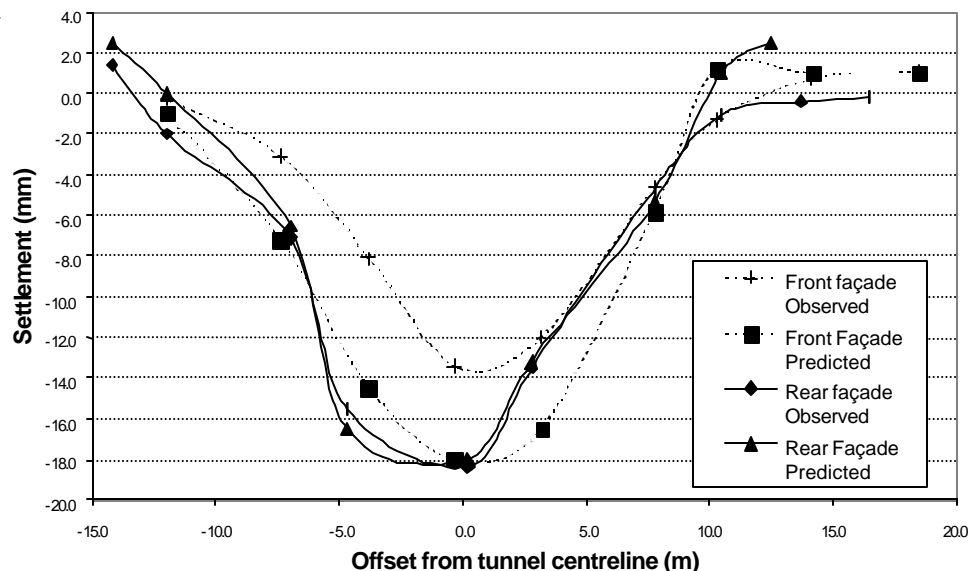
Figure 10: Predicted settlements along building facades and comparison with observations

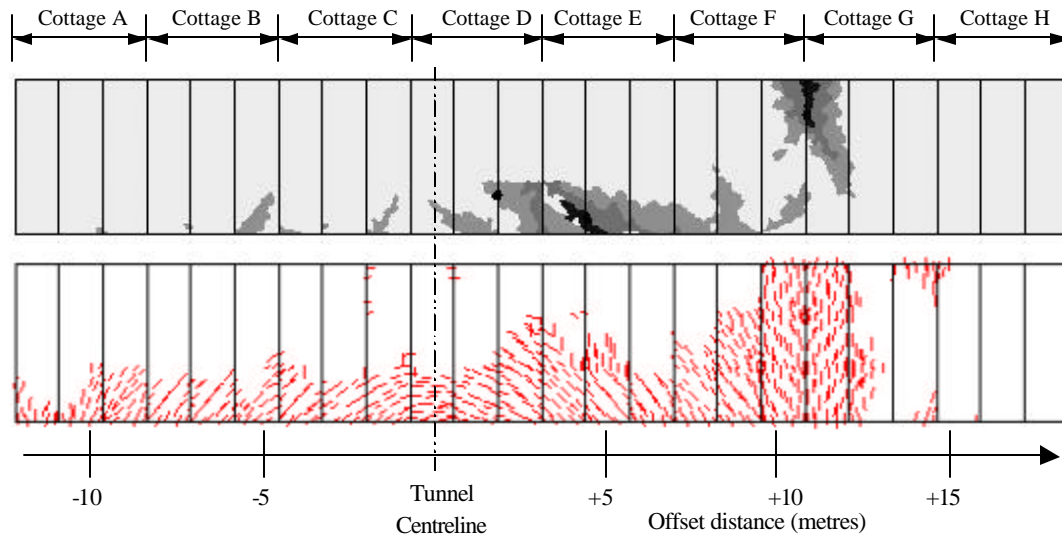
The effects of the tunnelling settlements upon the model of the building are shown in Figures 11 to 13 for the front façade, rear façade and a party wall above the tunnel respectively. The party walls suffered progressively less damage with distance from the tunnel axis. For each façade, the crack strain is contoured according to the categories in Table 1. In addition the crack

pattern is illustrated by a method in which a single line is drawn at each stress point for which the crack strain exceeds $500\mu\epsilon$. The direction of the line indicates the expected crack direction and its thickness the severity of cracking.

It may be seen that the facades are mainly undamaged, but where damage occurs it is mainly of Very Slight category, with isolated areas of greater damage. The average damage category for the facades is Very Slight.

Figure 11: Front façade damage category (key on Figure 13) and crack pattern, viewed from front of cottages

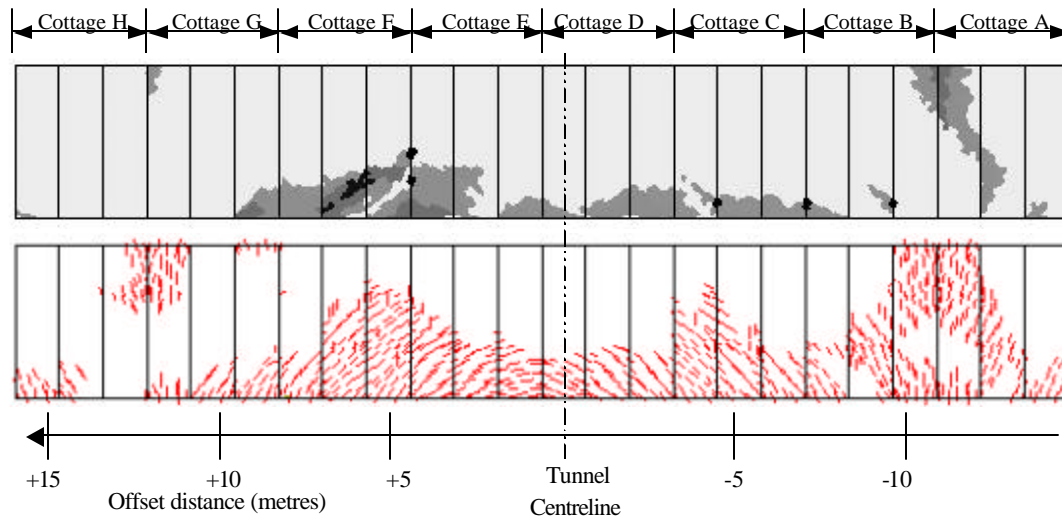
Figure 12: Rear façade 3 damage category (key on Figure 13) and crack pattern, viewed from rear of cottages

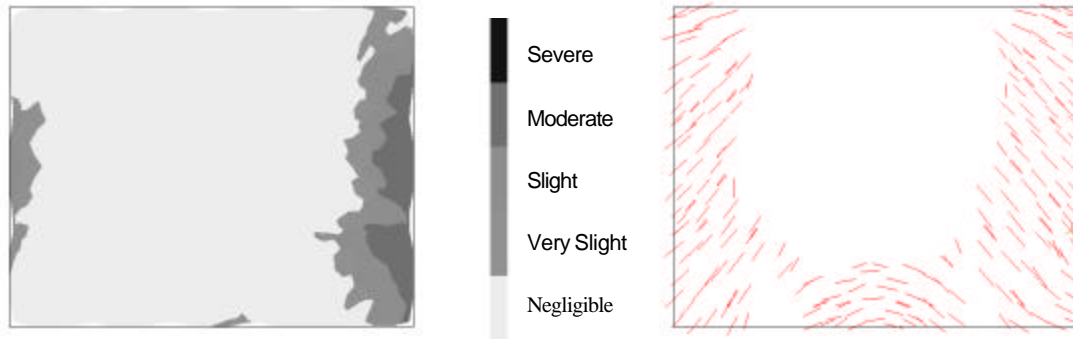
Figure 13: Damage category and crack pattern for party wall above tunnel centreline
